# Manhole Inspection Summary

Manhole # S45I\_\_045MH

Insp Date: **4/29/08 8:52 AM**

**Location** Address: **402 s ann st**

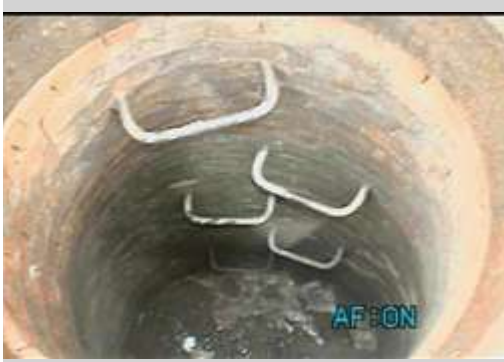
Defect 1

Count: **5** Missing: **0** ☒ **Corroded**

corroded stairs

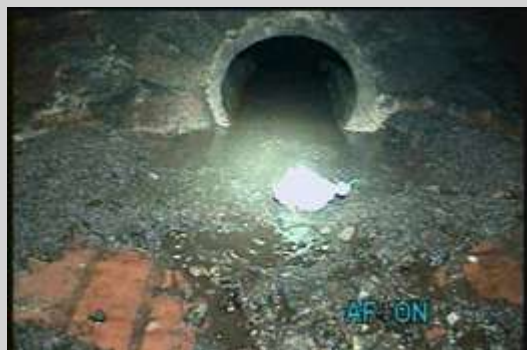
12 O'Clock Outflow

Deposits: ☐ None ☐ Mud ☒ **Gravy** ☐ Debris ☐ Grease

Silt Depth: **2** (in.) Deposits Extent: **Light**
